Slips and trips

(滑り及びつまずき)

この資料の作成年月：2026 年 3 月

この資料の作成者：中央労働災害防止協会技術支援部国際課

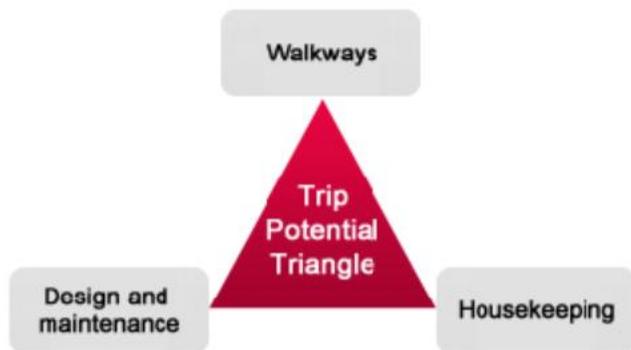
Walkways - Check for a suitable walkways? Are they in the right place, are they being used, are they available for use? What tasks are taking place on the walkway, is the task preventing the employee from seeing where he is going for example.

Housekeeping – It is not just good enough to have a walkway, it must be kept clear, no trailing wires, no obstructions. Employees and cleaners need to have 'a see it, sort it' attitude to ensure these and other work areas are kept clear. Is the cleaning regime effective? Are there enough bins, storage facilities etc?

Design and maintenance – is the floor suitable for the environment, fitted correctly and properly maintained. Are the walkways wide enough & level. Are stairs suitable, are risers consistent, are nosings highlighted where necessary, are usable handrails available. Environmental factors also fall into this category, is the lighting good enough for employees to see hazards, what about distractions that might prevent them from seeing where they are going.

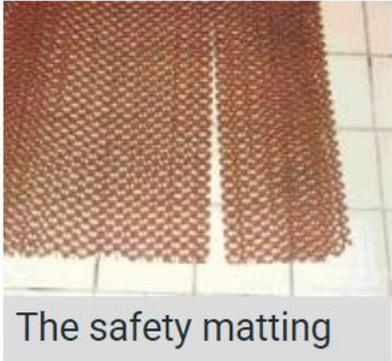
The company were also aware of numerous other slip accidents in similar situations at their other sites around the country. The Inspector served an Improvement Notice on the company to require them to deal with the slip risks to employees. After a number of other options were consider by the company, but concluded to be inadequate or inappropriate, they eventually replaced the floor surface with one that was suitable for use in an area where the total elimination of floor contaminants would never be possible. The new floor was specified to provide enough grip, even in wet or contaminated conditions.

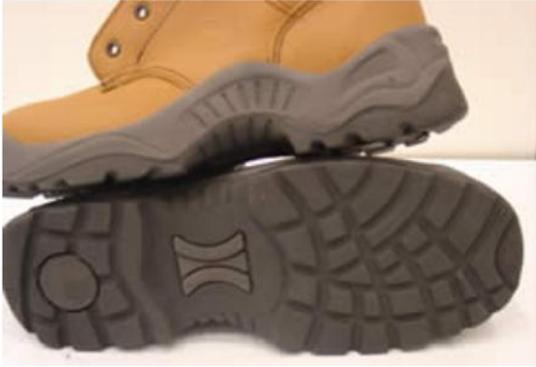
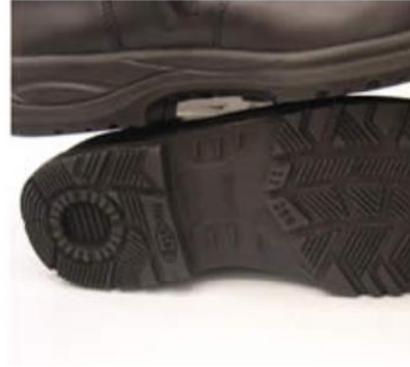
All boots performed well on gratings and scaffold boards (although the materials were brand new and may not have been representative of the condition of these surfaces at site locations). However, boots A and D performed poorly when confronted with the 'more challenging' conditions of the standard test. Boot A also gave little grip feedback to the operators.

ブーツ C は、テスト中に最も快適なブーツとして報告され、B は、高いランプ角度(すなわち斜面を下るときに)で快適ではないと報告されました。

同社は、ブーツ A をリストから削除し、D(現在のソールユニット)をその範囲に採用しないことにしました。これにより、滑りに関するスタッフの懸念が和らげられました。彼らは B と C を維持することにしました。

The company also decided to adopt the HSL standard test as the method of assessing grip capability of future footwear proposed for their 'approved' range. The acceptance criterion is that all footwear will perform above a minimum coefficient of friction of 0.24 (indicating moderate slip potential) in the standard test before being considered for their range. The company have charged their footwear supplier to challenge manufacturers to produce better footwear, which meets the new specification for grip and comfort, and they have responded by providing some new products for testing by HSL and subsequent trialling by staff.

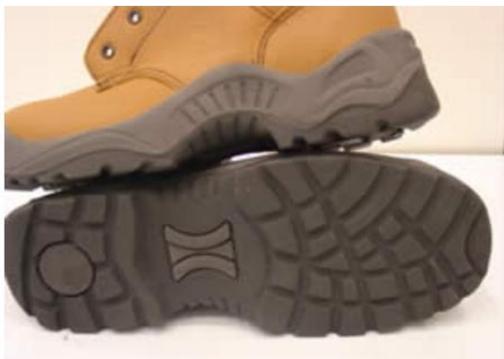
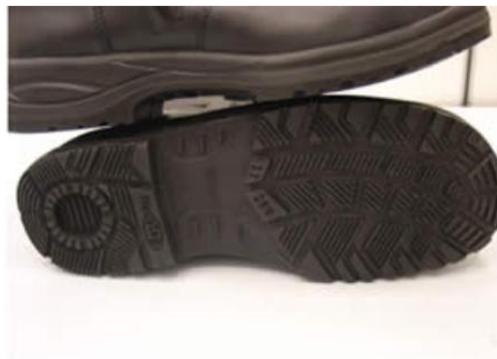
All boots performed well on gratings and scaffold boards (although the materials were brand new and may not have been representative of the condition of these surfaces at site locations). However, boots A and D performed poorly when confronted with the 'more challenging' conditions of the standard test. Boot A also gave little grip feedback to the operators.

Boot C was reported as the most comfortable boot during the tests, and B was reported as being less comfortable at high ramp angles (ie when walking down a slope).

The company decided to remove boot A from their list and not to adopt D (with the current sole unit) into their range. This helped to relieve staff concerns about slips. They decided to keep B and C.

The company also decided to adopt the HSL standard test as the method of assessing grip capability of future footwear proposed for their 'approved' range.

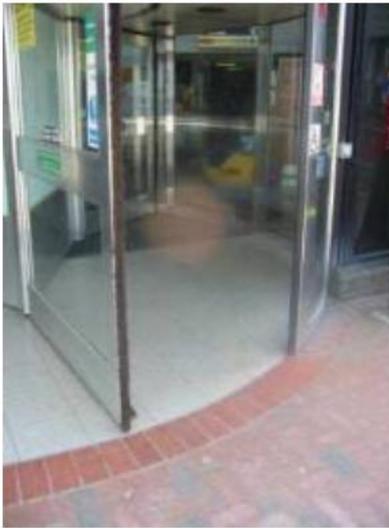
<p>汚染の可能性を制御するために、定期的な清掃システムを確認し、清掃直後に床が完全に乾いていることを確認しました。</p>
<p>Main revolving door entrance</p> <p>he principal passenger entrance to the terminal building is a large powered revolving door. The outer half of the floor within the revolving door is covered with ceramic tiles. These tiles have very low microroughness, are exposed to rain and dirt and are located where encumbered pedestrians (young and old) are rushing, turning and distracted. Slip risk was identified as being high. The inner half of the floor within the circumference of the revolving door consists of coarse grit/dirt removal matting. Although this has some absorbent qualities its design (and heavily worn condition) render it of little use in preventing walk-in water being carried onto the adjacent concourse where control of contaminants is known to be important.</p> <p>Response</p> <p>Arrangements are being made to have the revolving door removed and pedestrian flow redirected to a better-controlled area. A decision made easier by the 'temperamental' nature of these particular powered doors.</p>	<p>メインの回転ドアの入り口</p> <p>彼のターミナルビルへの主な乗客の入り口は、大きな電力回転ドアです。回転ドア内の床の外側の半分はセラミックタイルで覆われています。これらのタイルは微小な粗さが非常に低く、雨や汚れにさらされ、困惑した歩行者(若者と老人)が急いで、回転し、気を取られている場所にあります。滑りリスクが高いことが確認されました。回転ドアの周囲内の床の内側の半分は粗いグリット/汚れ除去マットで構成されています。吸収性のある性質はあるものの、設計(および重く着用された状態)は、汚染物質の制御が重要であることが知られている隣接するコンコースに歩行中の水が運ばれるのを防ぐのにほとんど役に立ちません。</p> <p>対応</p> <p>回転ドアを取り外し、歩行者の流れをより適切に制御されたエリアにリダイレクトさせるための手配が行われています。これらの特定の電動ドアの「温度」の性質によって容易にされた決定</p>

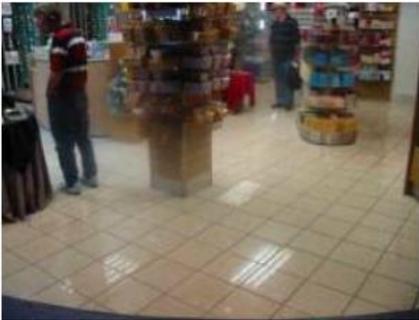
'Duty Free' shop

High gloss ceramic decorative floor tiling with low microroughness. Originally thought to be likely to be a high-risk area but this proved not to be the case. The duty free shop is sited in the heart of the terminal building

低微細度の高光沢セラミック装飾床タイル。もともとリスクの高い地域であると考えられていたが、これは当てはまらないことが判明した。免税店は、ターミナルビルの中心部にあり、歩行による水の危険性はありません。店が一般公開されている夜は、床の清掃が行われます。飲食禁止政策が施行されている。床を汚染するためのオープンな製品はありません。ボトルの破損反応と手順は非常によく整理されています。

Although the floor is glossy pedestrians never have anything other than a clean and dry floor to walk on. No action is needed.

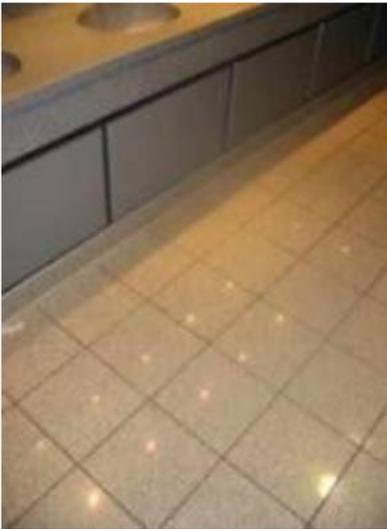
Passenger toilets

'Air side' - slip risk is low even in foreseeable wet circumstances. No action.
'Land side' - a real likelihood of slips occurring. There would be difficulties in bringing forward the floor replacement in advance of the next planned refit. Greater (labour costly) frequency and diligence of splash clean ups implemented and investigating etching treatment to the gloss terrazzo to improve surface microroughness and slip resistance in wet conditions.

「エアサイド」 - 予測可能な湿った状況でも滑りリスクが低いです。アクションはありません。'ランドサイド' - 滑りが発生する本当の可能性。次回の計画改修に先立ち、床の交換を進めることは困難であろう。スプラッシュクリーンアップの頻度と勤勉性の向上(コストがかかる)を実施し、グロステラツォへの滑り止め処理を調査して、湿式条件での表面の微細化と滑り抵抗を改善しました。

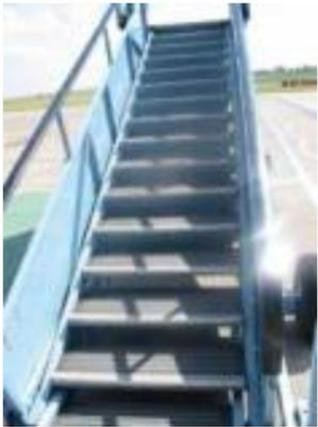
航空機へのアクセス手段

Periodic cleaning of the treads to control contamination and monitoring of the condition of the rubber surface for hardening or perishing brought on by exposure to the elements.

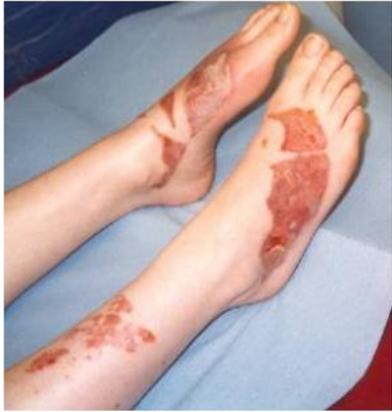
The catering assistant, who worked in the customer restaurant, received burns to her back when she slipped and fell on hot oil. The assistant had been emptying oil, thought to be in excess of 100c, from a deep fat fryer into a handle less plastic bucket, when the bucket melted allowing the oil to spill onto her feet and the floor.

The fryer had been replaced three months before the accident with one that didn't have an integral filter and collection tray, the company was unaware of this and failed to provide additional equipment for safely removing the oil.

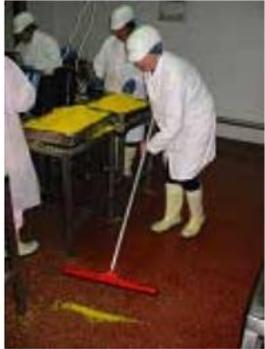
Designated person for removing spillages

Production lines no longer had fixed hose-pipes for swilling down as it was found that they had often been just left running resulting in a lot of water on floor surfaces and wasted money on water bills. Hoses can now be collected from the equipment stores when they are needed for cleaning down but must be returned. Instead, one person on each processing line is designated as being

<p>responsible for clearing away any food spillages as they happen. Floor contamination by water and product is now much less - so fewer slips.</p> <p>Trip incidents were looked at too. Records showed that these were caused most often by the uncontrolled way in which movable items, usually pallets, were placed around the work areas during production. Designating 'pallet points' and marking them with floor lines kept the pallets used for work where they were needed, away from walkways, where everyone knew that they were and made it obvious when they had been left where they should not be. It became an ingrained good habit for staff to follow and 'self police' this simple safe practice.</p> <p>The floor surfaces were looked at and some areas were found to be life expired - they were worn out. These were prioritised for replacement. Other floors not in the processing areas were also looked at and matting introduced to stop wet soles transferring water from production rooms onto smooth floors elsewhere.</p> <p>When the initial decision was made to put the spotlight on health & safety, starting with slips & trips, management did wonder whether it would be a long process to achieve noticeable improvements. They were, in fact, able to show a 34% drop in slip & trip incidents over the course of the first year. It was also apparent that this went hand in hand with the shift in attitudes towards these incidents. From senior managers to the shop floor, everyone 'signed up' to making a difference and they were encouraged to see that their efforts and involvement were having a real effect.</p>	<p>製品による床の汚染は、今はるかに少ないです - 滑りが少なくなります。</p> <p>つまずきの事件もまた見られました。記録によると、これらはほとんどの場合、生産中に作業エリアの周りに移動可能なアイテム、通常パレットが配置された制御されていない方法によって引き起こされたことが示されました。「パレットポイント」を指定し、床の線でそれらをマークすると、歩道から離れて、必要な場所で作業に使用されるパレットは、誰もがそれらが存在することを知っていて、彼等がいるべきではない場所に残されたときにそれを明らかにしました。スタッフが従うための良い習慣となり、この単純な安全な慣行を「セルフポリシー」しました。</p> <p>床面を調べ、一部のエリアが寿命が切れていることが判明しました - それらは磨耗していました。これらは置き換えが優先されました。加工場のない他の床もまた、生産室から他の滑らかな床に水を移す湿った床を止めるために調べられ、嵌め込みが導入されました。</p> <p>健康と安全にスポットライトを当てるといふ当初の決定がなされたとき、スリ滑り及びつまずきから始めて、経営陣は顕著な改善を達成するための長いプロセスであるかどうか疑問に思っていました。彼等は、実際には、最初の年の間に滑りおよびつまずきの事故の 34%の減少を示すことができました。これがこれらの事件に対する態度の変化と相まっていることも明らかでした。上級管理者（シニア管理者）から販売現場（ショップ床）まで、誰もが「サインアップ」して違いを生み出し、彼等の努力と関与が本当の効果を持っていることを確認することを奨励されました。</p>
